# **Comparing the Moisture Performance of Wood Framed Wall Systems in the Pacific Northwest**

Prepared For:  
Roof Consultant Institute / Building Envelope Institute  
2005 Symposium on Building Envelope Technology

Prepared By:  
Chuck Murray  
Washington State University Extension Energy Program  
925 Plum Street, Olympia, WA 98502  
360 956-2157  
cmurray@energy.wsu.edu

Publication number:  
WSUEEP05-020 9/26/2005

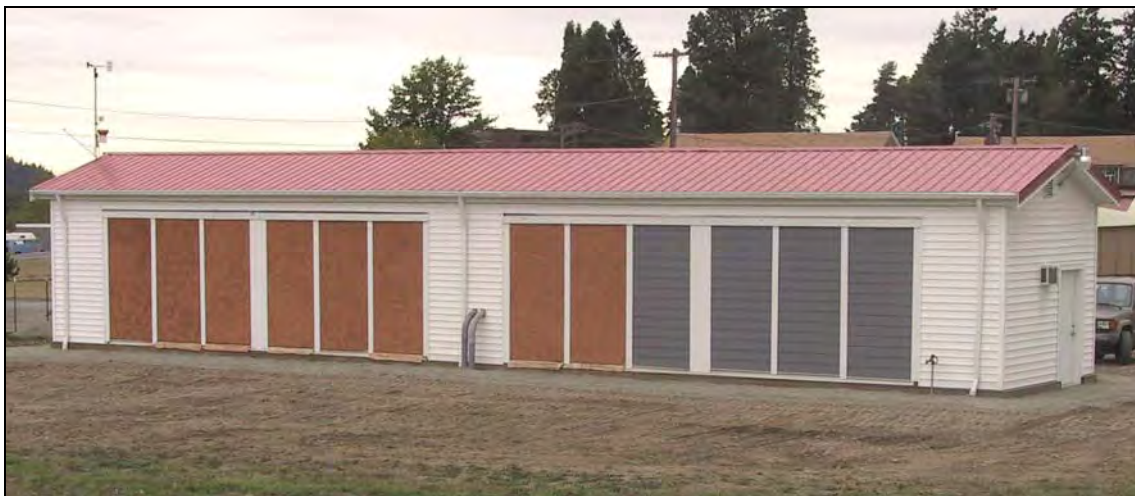
**Figure 1. WSU Natural Exposure Test Facility**

For this project, Washington State University has established a test facility specifically designed to monitor moisture transport in building assemblies. The Natural Exposure Test Facility (NET) will accommodate up to 24 4x9-foot test walls, 12 facing south, and 12 facing north. For this report, all 12 of the test walls are facing south.

NET instrumentation provides hourly data on the wood moisture content (MC), relative humidity (RH), incidence of condensation and temperature (Temp) distributed through the cross section of the test walls. Sensors are located at critical areas of the walls identified during previous field studies, and through computer modeling. Through the examination of this data, the moisture performance of test walls can be evaluated. The test facility is shown in Figure 1.

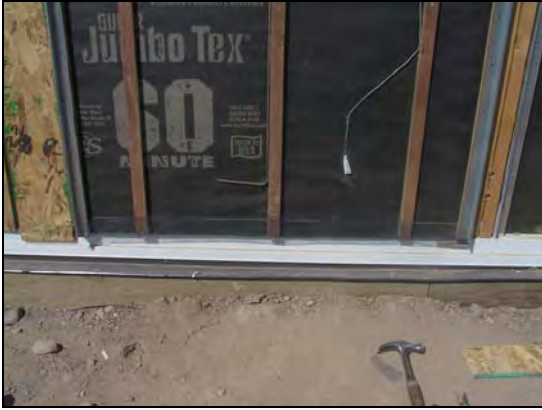
**Figure 2. Strapping that creates ventilated cladding**

To assess the value of providing ventilation between the cladding and the weather resistive barrier, two ventilation strategies are compared to walls without ventilation. To construct a ventilated cladding system, 3/4" furring is attached to the walls 16" on center. The cladding is attached to the furring strips. The **ventilated** cavity is open at the bottom and at the top of the wall to provide flow-through ventilation. The **vented** cavity is identical to the ventilated, except the cavity is only open at the bottom. Figure 3 shows a test wall with ventilated cladding under construction.

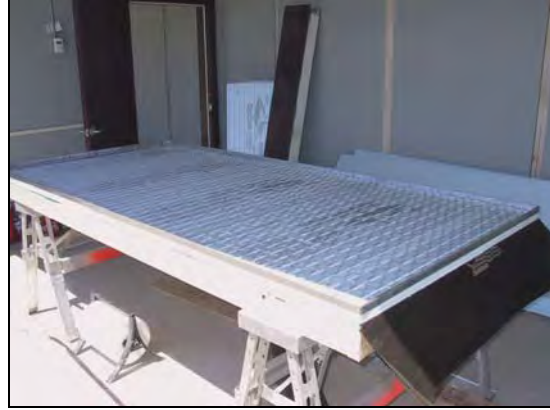
**Figure 3. Foam sheathing test wall**

Because of stringent energy code requirements in the Pacific Northwest, typical wall construction for residential buildings is 2x6 wood framing insulated with R-21 fiberglass batts. A construction that provides similar thermal performance is a 2x4 wood frame with R-13 batts and R-5 continuous foam sheathing. To represent wall construction typical 25 years ago, a 2x4 stud wall with R-11 Kraft faced batts was included in the study. Figure 4 shows a foam clad test wall under construction.

Test Wall 8 is a stucco-clad wall constructed using 2x4 framing, R-13 cavity insulation, and R-5 foam sheathing. The alternative insulation method using R-21 insulation in a 2x6-framed cavity is best represented by test Wall 2. Both test Wall 8 and test Wall 2 also include smart vapor retarders.

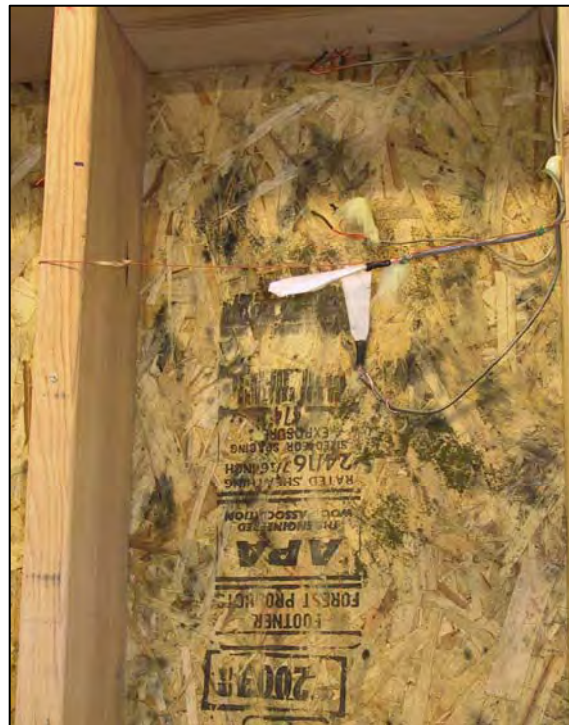
**Figure 5. Mold resulting from inadequate vapor retarder control on Wall 7**

Wall 7 performed poorly. RH in the insulated cavity was very high most of the winter. At the exterior sheathing, the RH reached 100 percent and stayed there. This resulted in high levels of moisture accumulation in the winter. MC readings of the exterior sheathing exceeded 30 percent for months. When the wall was opened in the spring, there was significant mold accumulation on the exterior sheathing. Obviously, a vapor retarder is important given the environmental conditions present during the test.

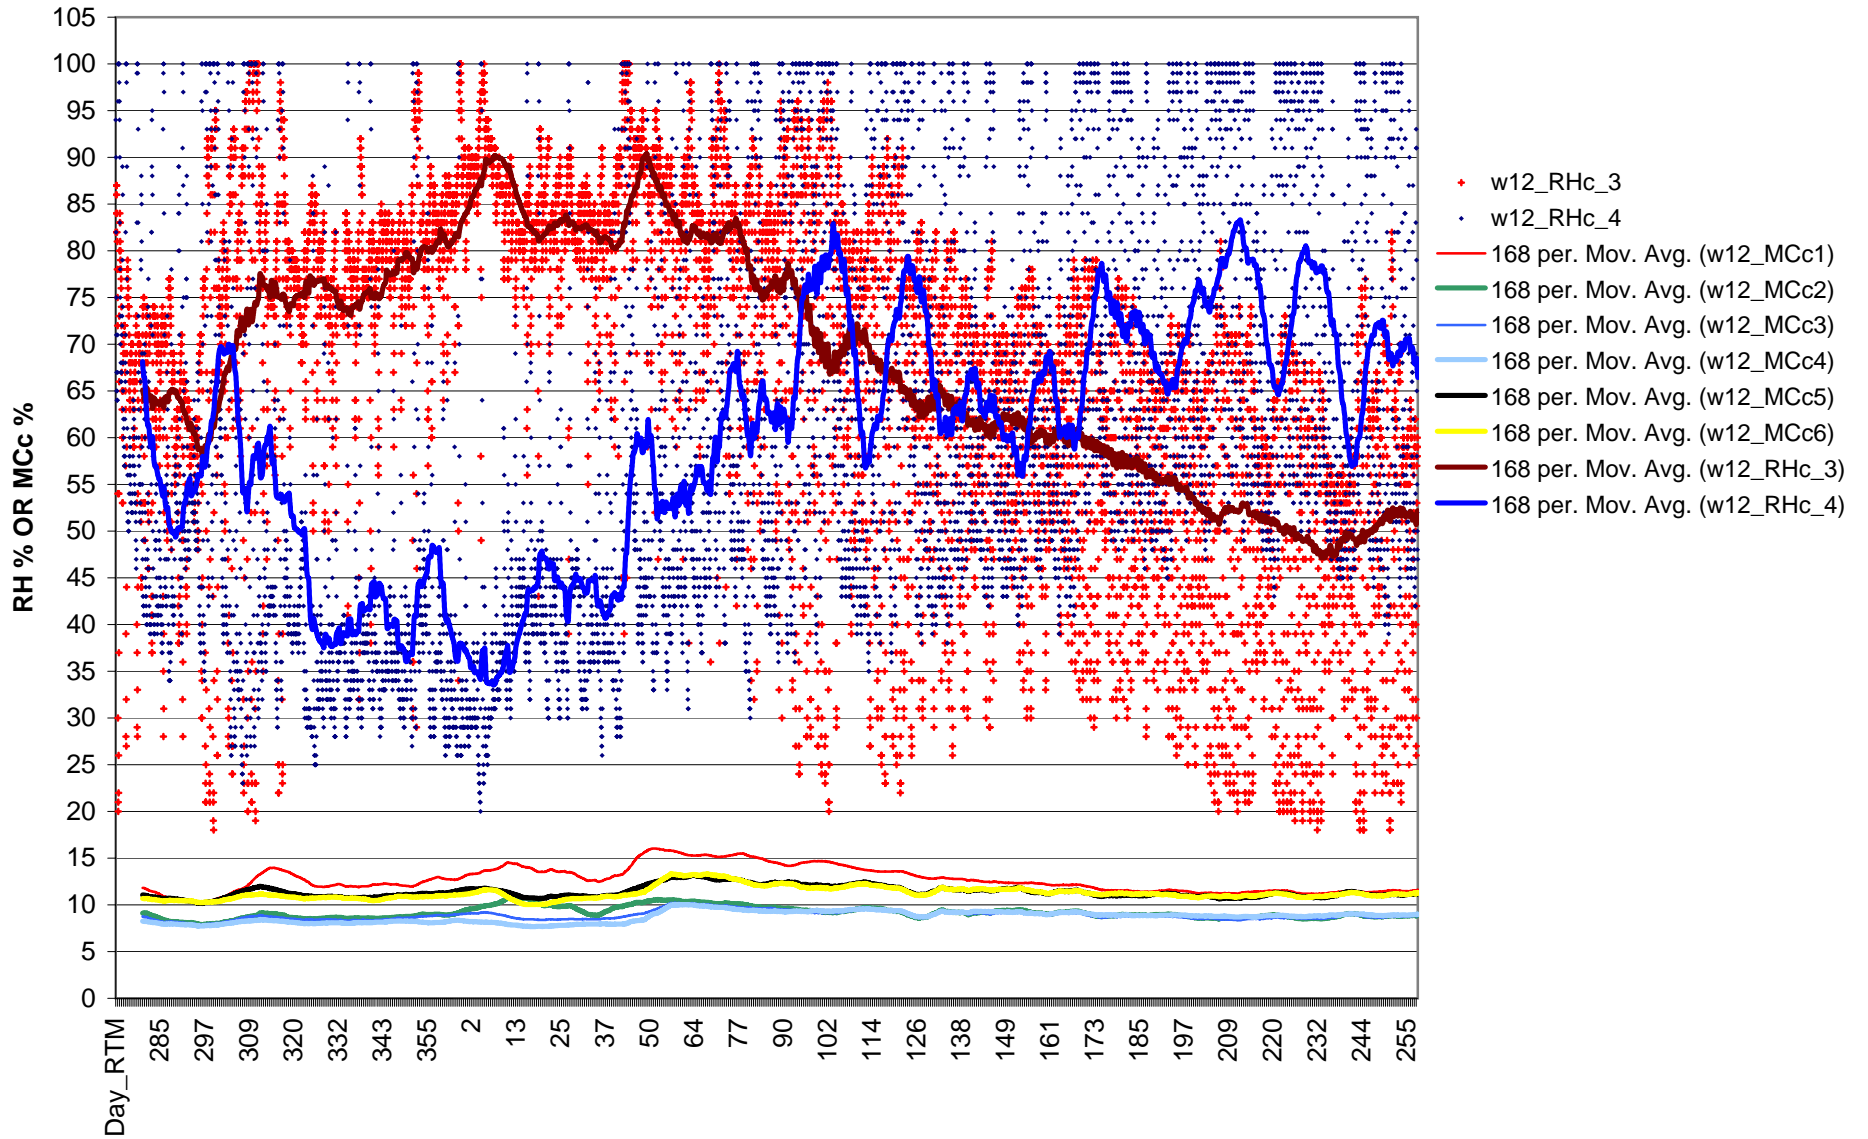
### Wall 12

Latex - Drywall - Poly - 2x6 - R-21 - OSB - 2x 60min - Cement lap  
10/1/2003 to 9/14/2004

All three walls remained very dry during the test cycle, making it somewhat difficult to provide performance comparisons. Both the vented and ventilated lap walls have slightly lower MC than the standard lap wall assembly. A distinction between the vented and ventilated case cannot be made. The RH in the cavity of Walls 10 and 11 is lower than Wall 12. This indicates a dryer wall, with less chance for condensation on either the interior or exterior surface. Cladding ventilation strategies demonstrated here do show promise. But more extreme test conditions will be needed to better define the margins of difference.

Wall 9 and 12 provide a comparison between OSB and plywood for a lap sided wall. Little difference in performance can be observed. These walls are dryer than the stucco clad walls.
